**Geology and Hydrogeology Assessment
Report for the Brooks Road Landfill Site
Vertical Capacity Expansion
Environmental Assessment**

**Brooks Road Landfill Site
160 Brooks Road
Haldimand County, Ontario**

**JULY 2016 (UPDATED OCTOBER 2016)
REF. NO. 018235 (64)**

Gypsum Mine Investigation Report

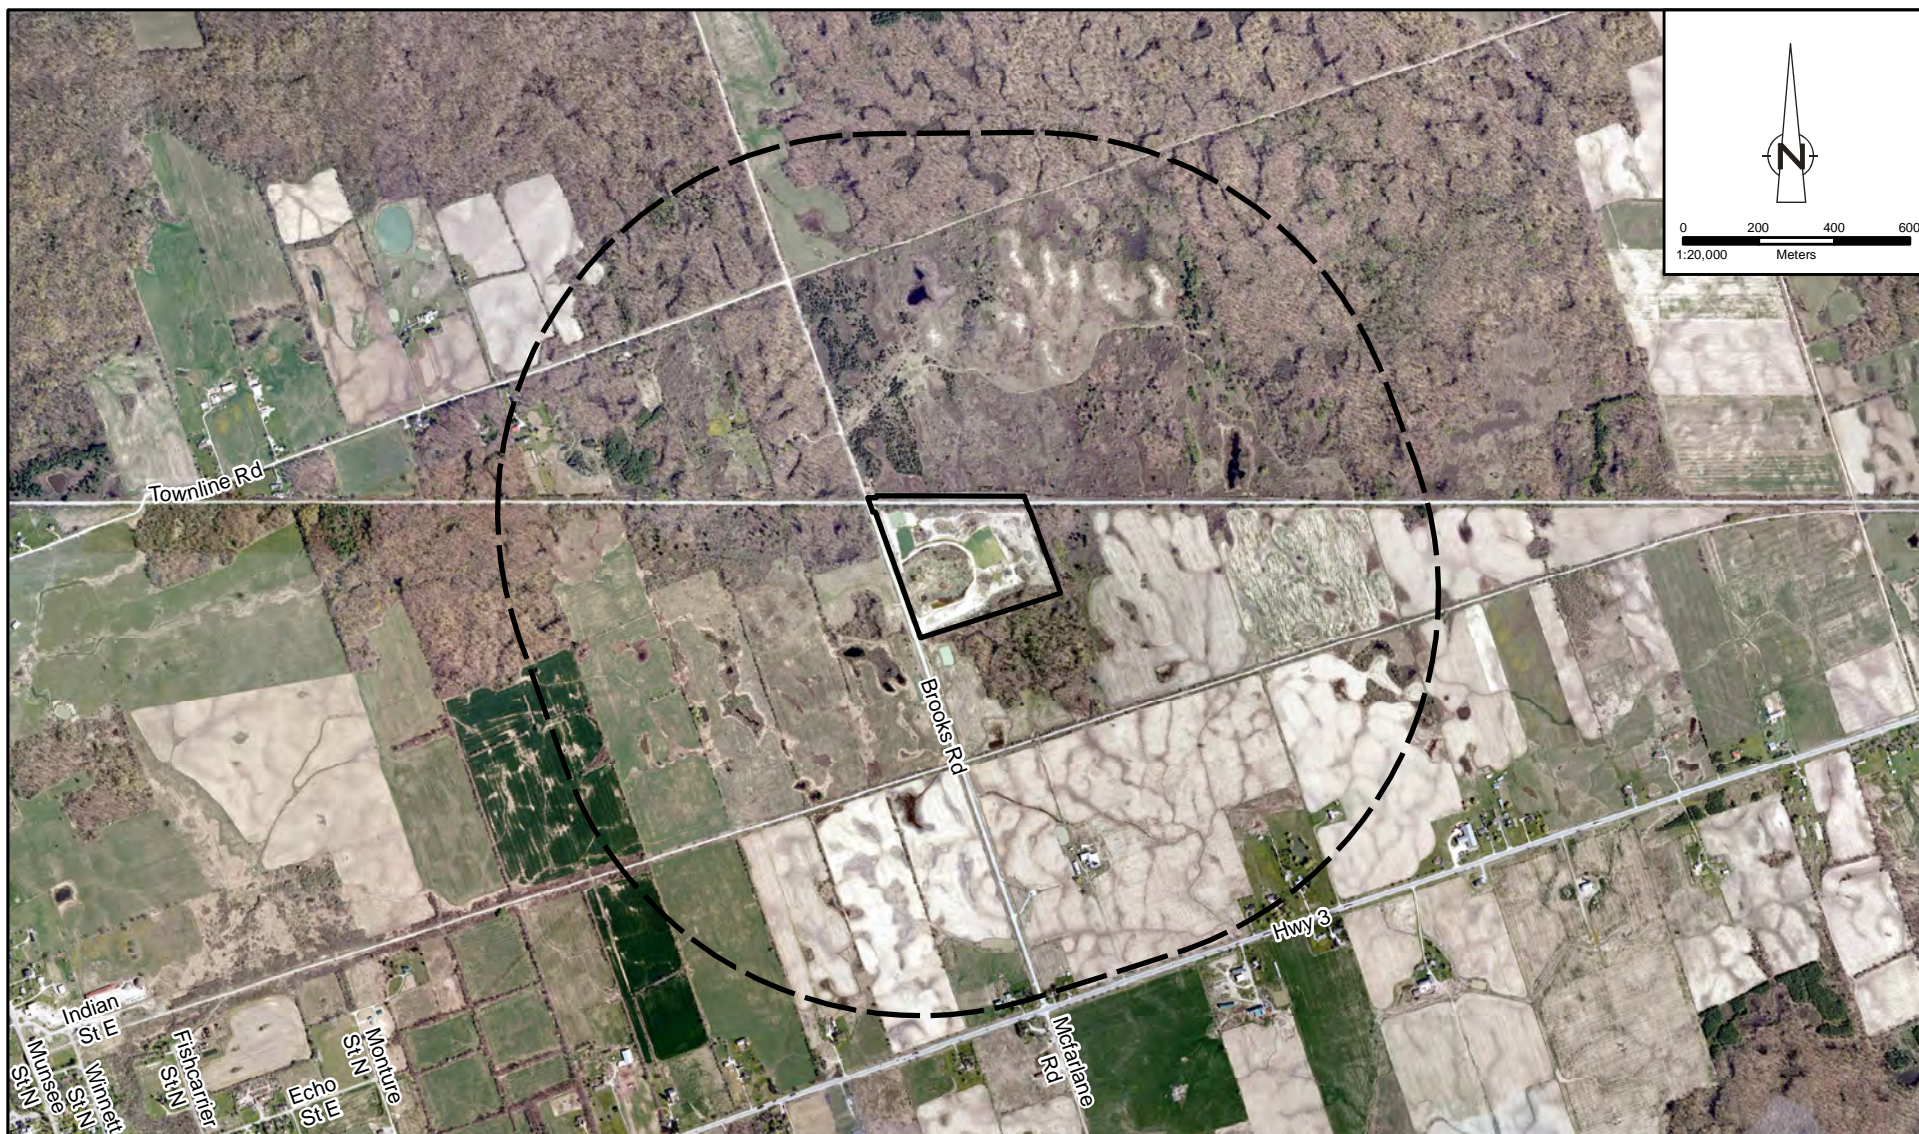
As provided for in the approved ToR, each technical discipline may modify the Local Study Area, as required, during the EA. For Geology and Hydrogeology both the Site and Local Study Areas are applicable (see **Figure 3.1**).
